Rolapp Mine, Tramway

HAER No. UT-53

Location: In Price Canyon, at the mouth of Bear Canyon, 4 miles northwest of Helper, Carbon County, Utah (SW/NE/NE/NW Section 35, T12S-R9E)

Date of Construction: ca. 1913

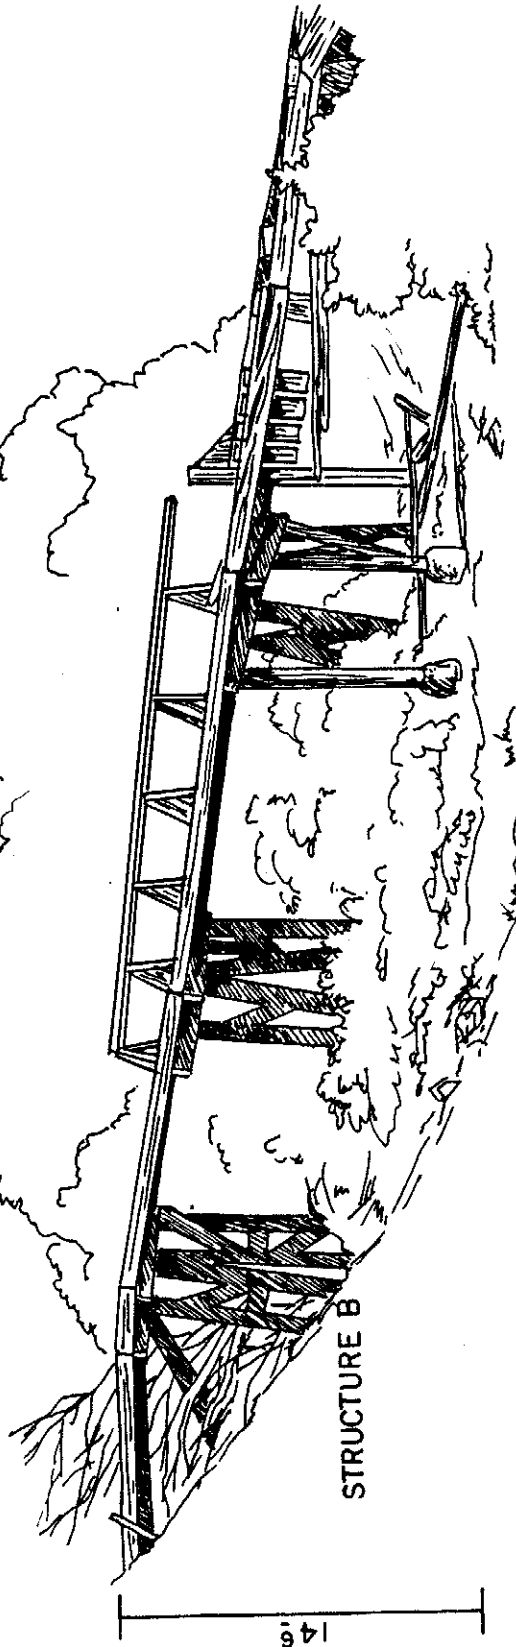
HAER No. UT-53-B

Drawn by Sharon Dolan 10/87

0 10 FT.

The Rolapp tramway is in fair to poor condition. The earthen tramway has been damaged by bulldozing on its south end. The wooden trestle has partially collapsed on the north end, and the hoisting house is roofless and gutted. Nevertheless, the overall configuration of the tramway is intact, and sufficient physical remnants allow interpretation of its function.
